CYCLIC RESPONSE OF RC HOLLOW BOX BRIDGE COLUMNS STRENGTHENED USING CFRP AND RC JACKETING

Abstract

Keywords: CFRP jacketing; Cyclic response; experiment; hollow box bridge columns; RC jacketing; seismic response; shear strengthening.

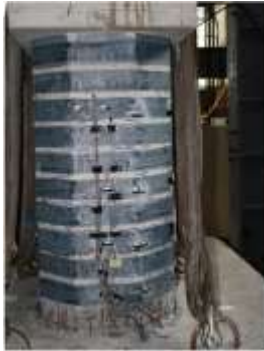
Figure 8. Column, strengthened by CFRP strips after the experiment

The response of both strengthened columns was, in general, similar. Both strengthening techniques efficiently prevented the shear failure of the column (see Figures 8 and 9). The cyclic response and the type of failure were similar. The spalling of the concrete cover at the outer and inner edges was firstly observed. It was followed by buckling and the rupture of the longitudinal bars. The pull-out of some of the longitudinal bars was also observed. In both strengthened columns pronounced horizontal crack was observed at the bottom of the column near the footing. The rupture of the longitudinal bars was followed by substantial rocking of the column. After successful shear strengthening of the column, the other unfavourable types of failure induced by the other construction deficiencies (see Introduction) were activated.

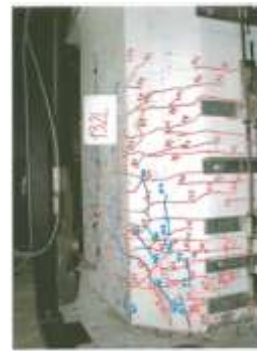
Figure 9. Column, strengthened using RC jacket after the experiment

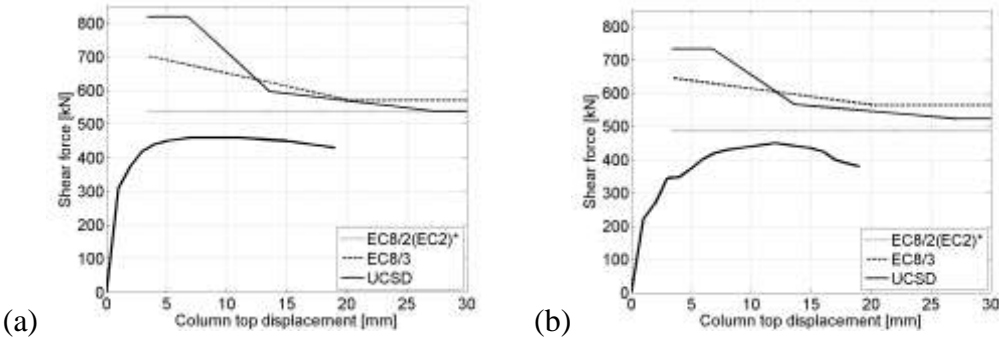
Figure 10. Shear strength of (a) column strengthened using CFRP strips, (b) column strengthened using concrete jacket

The shear strength of the strengthened columns was estimated in a similar way as for the as-built columns using the same analytical procedures. The contribution of the RC jacket and FRP wrap to the shear strength was added to contributions of other three mechanisms (V_C , V_N and V_W). The shear strength of CFRP wrap was estimated according to the [3] and [4]. In the case of RC strengthening the contribution of the jacket to the shear strength was determined taking into account its shear reinforcement in the same way as the V_w was defined. The shear

strength in the case of the CFRP and RC jacketing is summarized and compared with the shear demand in Figure 11. All considered methods predicted that the used amount of jacketing was sufficient to prevent the shear failure, as it was later proved by the experiment.
