SMART FRP USAGE FOR PREVENTION IN STEEL GIRDER BRIDGES AGAINST CHLORIDE ATTACK

This paper mentions the corrosion progress profile of the steel plate girder bridges under chloride attack and a rational method that prevents the attack by using FRP plates smartly. At first, it is confirmed by the laboratory tests and the bridge monitoring that the steel corrosions are promoted remarkably by existing of the surface chloride contents. The wind tunnel tests are also performed in order to confirm the wind flow in the inside of the bridge structure. From the monitoring and the wind-tunnel-testing, the corrosion damage parts of the bridge girders and the transfer path of the aerosol chloride particles carried by wind between the girders become clear. Based on the clarified results, a construction measure to protect the girder system from the corrosion damage by closing the bridge cross section between the girders with FRP plates is proposed. Moreover, the FRP plates can be used as the inspection way. This smart FRP usage is applied to a steel girder bridge erected in Okinawa, Japan. The monitoring on the prevention effect obtained by the FRP cover plate is continued.

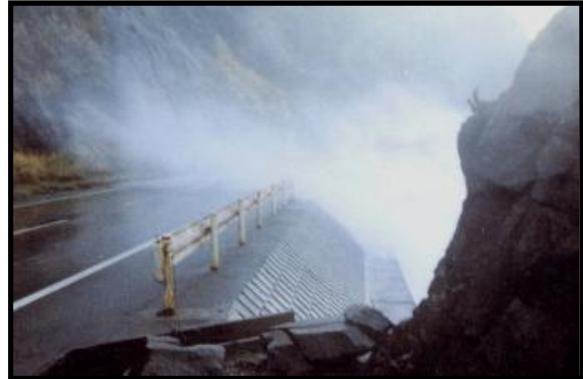
Splashing of the salt waters over breakwaters at seashores generates aerosol chlorides as shown in **Fig.1**. The aerosol chloride particles are transported around the girders in the vicinity of the seashore by the wind flow. Since the kinematic behaviour of the wind depends on the parts of the girders, the chloride contents attached to the surfaces of the girder are different from those parts. The accumulation of the surface chlorides is also different. It is practically needed to clarify the wind vortex between the bridge girders and the profile of the surface chlorides.

Figure 1. Splashing of salt waters.

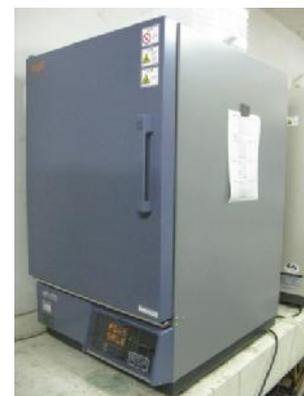
The temperature and humidity cabinet shown in **Fig.2** is used for the rapid corrosion tests. The cabinet used for the test is able to keep the inside temperature and humidity under control. The inside temperature and humidity of the cabinet are controlled by cyclical repetition of wet and dry during the test period. One cycle is composed by 9 hours, in which first 3 hours of wet condition (*temperature 35 °C, humidity 90%*) and following 6 hours of dry condition (*temperature 40 °C, humidity 50%*). Mild

Figure 2. Test cabinet.

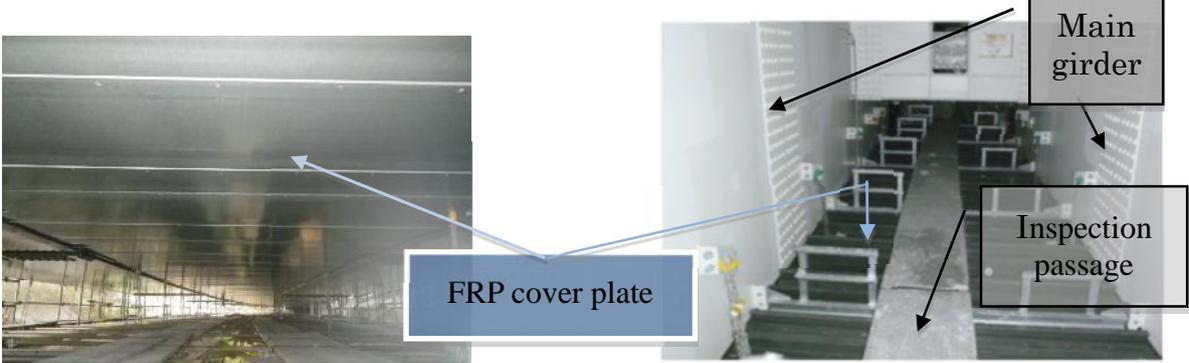
The provision of the FRP cover plate (plate thickness = 6mm, flange thickness of stiffener rib= 10mm) is applied to a steel box girder bridge, which has been erected recently in Okinawa, as shown in **Fig.13**.

(a) Bridge cross section closed by FRP cover plate

(a) Outside bottom view

(b) Inside view

Figure 13. FRP cover plate applied to a steel box girder bridge
